Brake Rotor Installation Tips

To assure pulsation free performance over the life of your brakes

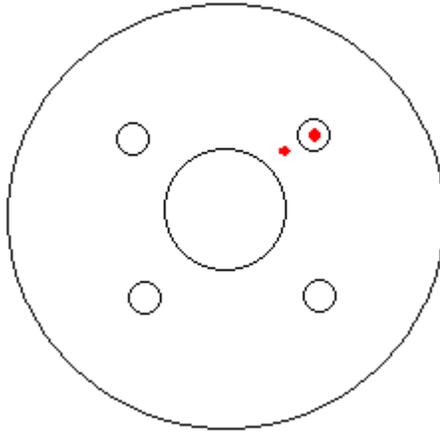
- Confirm that the hub and rotor mating surfaces are clean and free of any rust, dust, or other debris, install the rotor onto the hub, and mark the initial position with a paint mark on a lug stud and next to the corresponding lug hole.

- Measure rotor runout, recording the ZERO location and the high spot location, as well the amount of runout on the surface of the rotor with a marker.

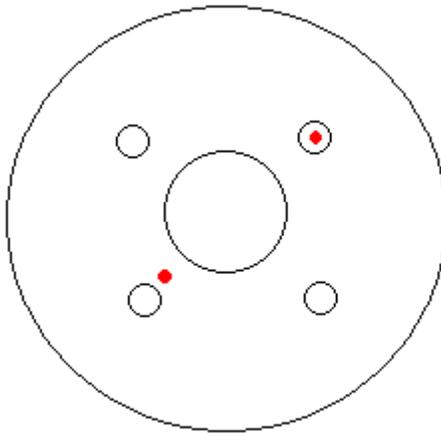
- Next, remove the rotor and install in a different position on the hub:

Measure runout and record results once again. If the results from both measurements match in both location and amount of runout measured, then excessive runout exists in the rotor itself, and the rotor requires either replacement or machining.

- If the results from both tests are marked in different locations on the rotor, then runout exists in the hub. If this is the case, cleanliness of mating surfaces should be confirmed once again, and then hub runout measured to confirm previous results. Any measurable hub runout requires hub replacement or a more short term solution of machining the disc on the hub using an on-car lathe. An on-car lathe will yield a finished product that compensates for any hub runout and if done correctly, will result in a rotor with ZERO installed runout when mounted to the hub in the same position in which it was machined. Any hub runout will show up as a considerably higher number when measured at the edge of the rotor....the larger the rotor, the greater the increase in measured runout.
